Frost Resistance of Cover and Liner Materials for Landfills and Hazardous Waste Sites

Edwin J. Chamberlain, Allan E. Erickson,
and Craig H. Benson

Special Report 97-29

Cold Regions Research &
Engineering Laboratory

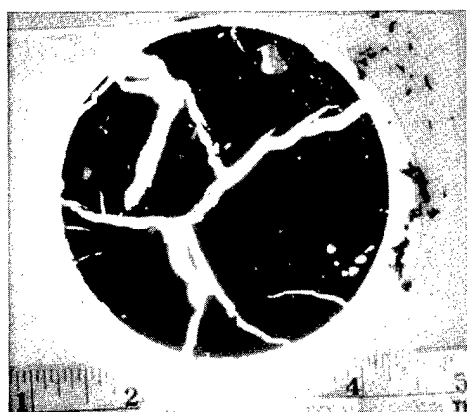
Figure 9. Thin section of a horizontal slice of frozen Valley Trail clay. Note thick ice features (white) in shrinkage cracks surrounding clay aggregates (black).

This increase in hydraulic conductivity is attributed to the formation of cracks from ice lenses and shrinkage. Thin sections (Fig. 9) and half sections (Fig. 10) cut of these materials show the ice-filled cracks between aggregates of soil. A scanning electronic microscope (SEM) photograph (Fig. 11) shows further detail of a crack

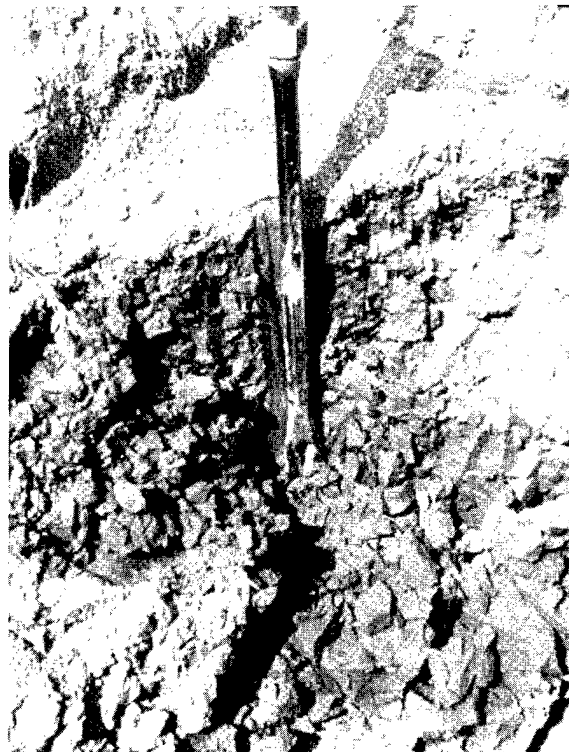
Figure 12. Test pit showing blocky soil structure caused by freeze-thaw cracking—Valley Trail test pad.

after thawing. Excavation in the test pads after thawing was complete exposed structures (Fig. 12) consisting of many block-aggregates, approximately 1 in.³ (1.6 cm³) in size, separated by vertical and horizontal cracks.
